Woodwinds Condominium-FY18

Reston, VA

Level I Full Reserve Study

October 28, 2017

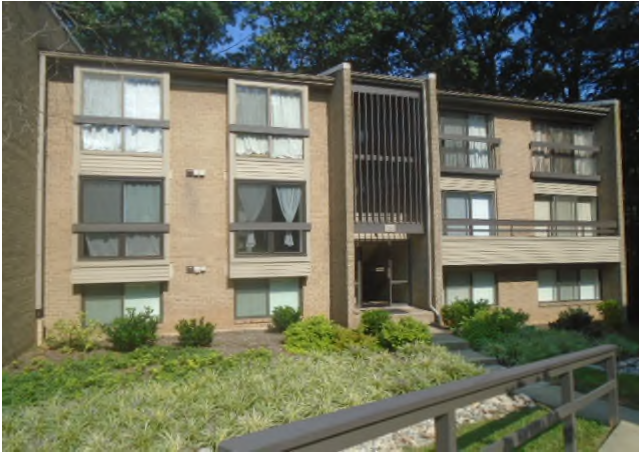
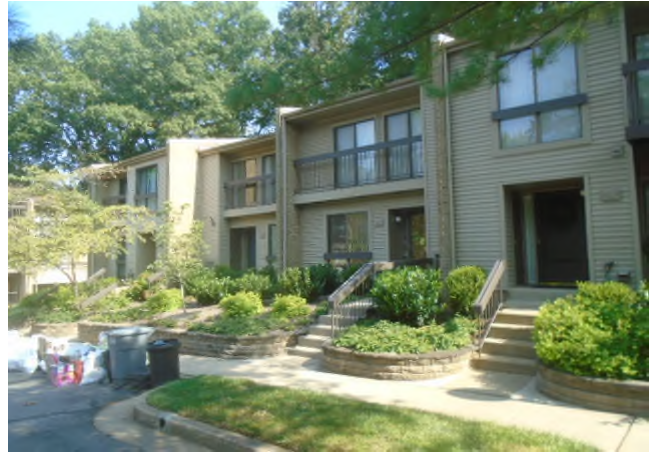
Woodwinds condominium is a 144-unit community, consisting of both garden and townhome style buildings and is located in Reston, Virginia. Left photograph is typical of the garden style buildings, right photo of townhome buildings. All exterior components of the buildings are association responsibility.

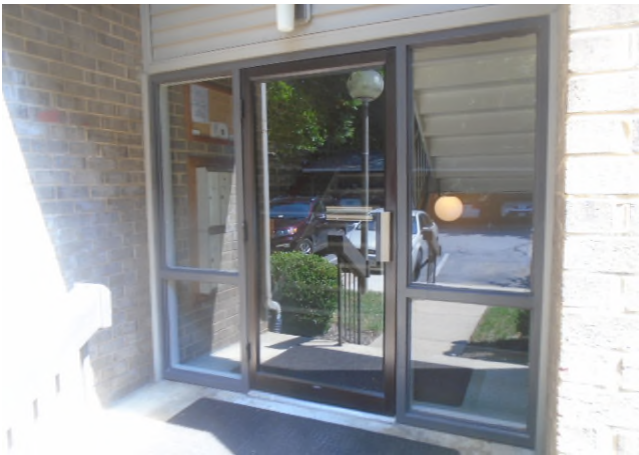
Garden entrance doors are holding up well.

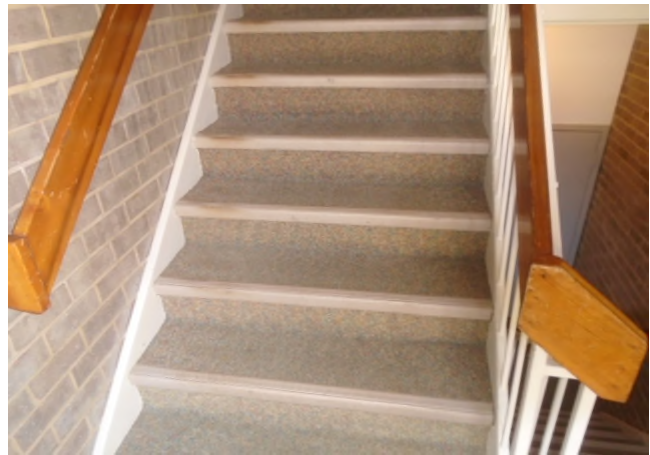
A contract has been awarded to replace carpeting in stairways. Work is scheduled to be done in FY17.

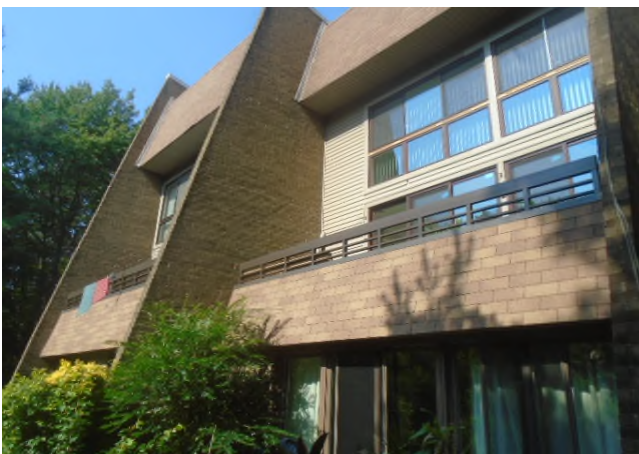
To date, 51-rear balconies have been reconstructed, remaining units are scheduled to be completed over the next three years.

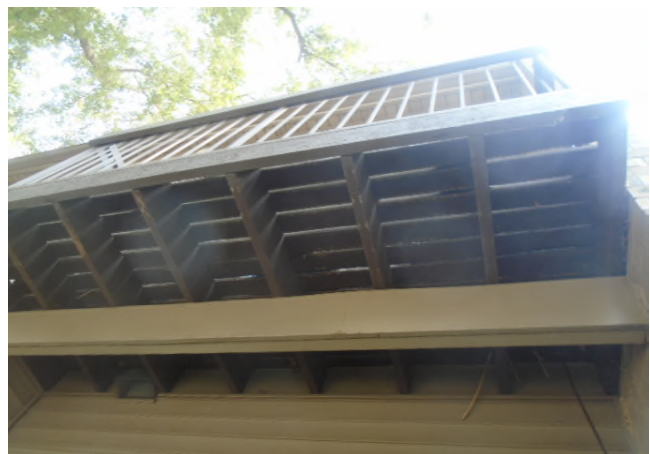
Work to reconstruct front balconies on both garden and town homes is planned to begin after rear balcony work has been completed.

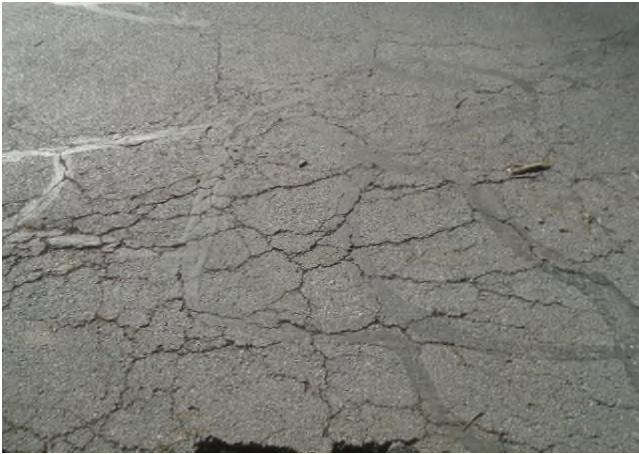
A contract to mill and overlay all asphalt pavement has been awarded and work is scheduled to be completed in 2017.

Because the non-carport areas are being milled to 4" this year, we do not believe that depth will be required again; therefore, we reserve for 2" milling for the next cycle of work. After the pavement work is completed this year the following recommendations should be implemented to extend pavement useful life. 1) Have a preventive maintenance program - preventive maintenance consist of sealing open cracks (equal to or greater than 1/8"), repair wearing surface/base/sub-base areas that have failed (distinguished by "alligator" or "chicken wire" cracking), apply a seal coat to the entire surface and repaint traffic markings. An additional benefit of sealcoating and traffic markings is the pavement will look uniform and that enhances property appearance. Funding for this work is identified as "Preventive Maintenance" and/or "Immediate Repairs for Life Extension." Although we allow for preventive maintenance to be done every four years, if cracks open or asphalt failures occur sooner they should be repaired as needed. Contingency built into the funding plan should be more than adequate to fund this work, 2) Be prepared to repave all asphalt around the time period shown in the table. When repaving there are two possible courses of action, a) mill only near gutter pans to preserve proper drainage and place back 1-1/2" (or more) of compacted asphalt throughout, and b) total milling of all asphalt and repave to thickness removed. Notes: a) Asphalt is an oil based product - price varies with the cost of a barrel of oil, and b) When pavements are shared with adjacent properties quantity shown is one-half the shared amount. 3) Although we allow for 100% of the asphalt to be repaved our experience supports a smaller percentage of the base/sub-base will need repairs prior to overlaying.

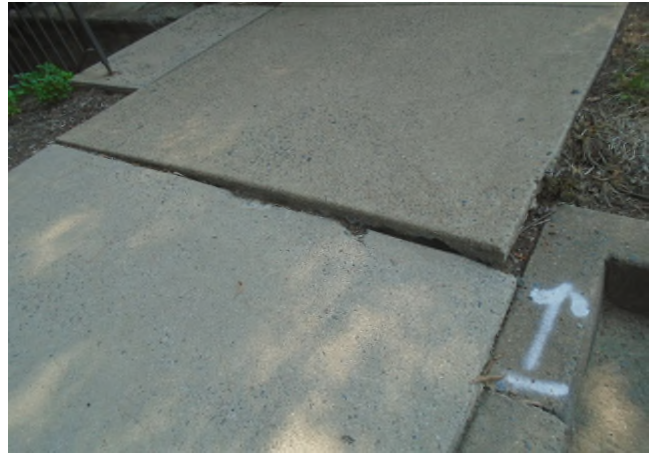
Pavement contractor has also been awarded a contract to replace deteriorated and damaged sections of sidewalks, curbs and gutters.

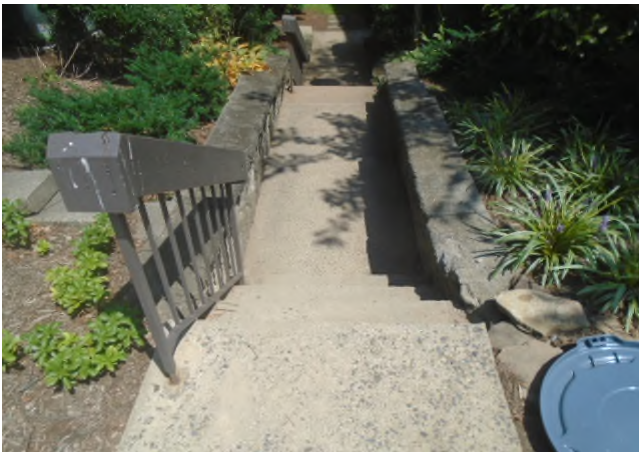
Retaining walls between 11630-11636 have slight leans to them. Walls are structurally sound at this time but should be monitored and repaired when needed.

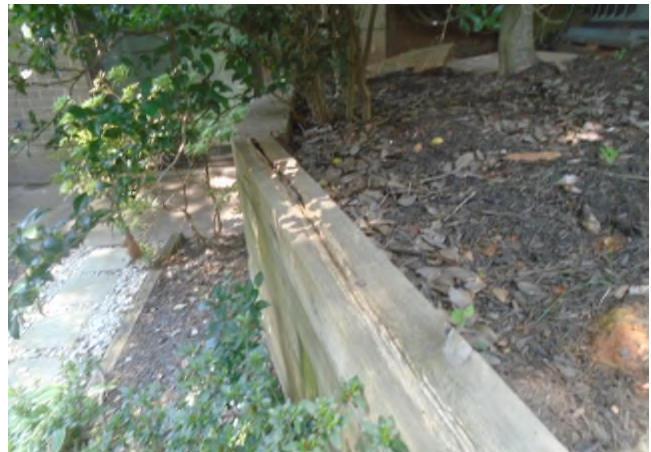
Top member of wood retaining wall is deteriorating. Member can be replaced without replacing the entire wall. When total replacement is needed, install a low maintenance modular block system.

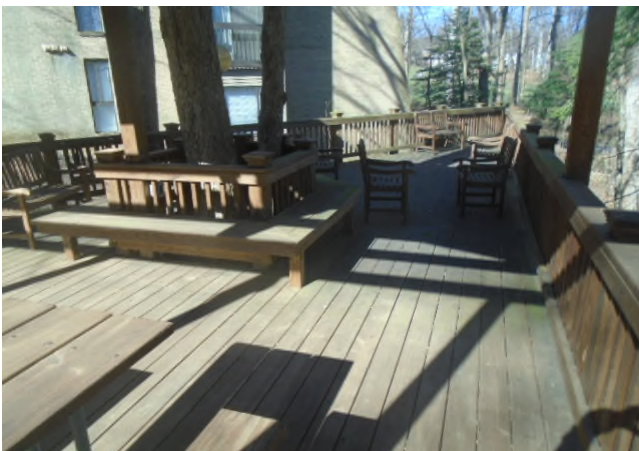
Reserve provides for pressure washing, staining and eventual replacement of wood deck with composite materials.

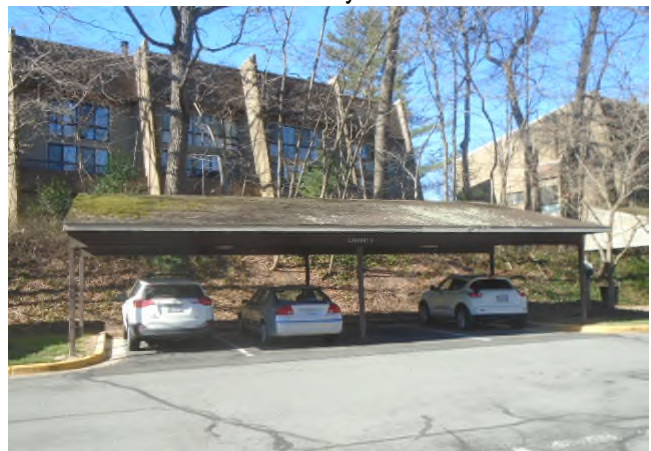
Reserve budget assumes carport roofs will be replaced in F18 and repainted in FY19.

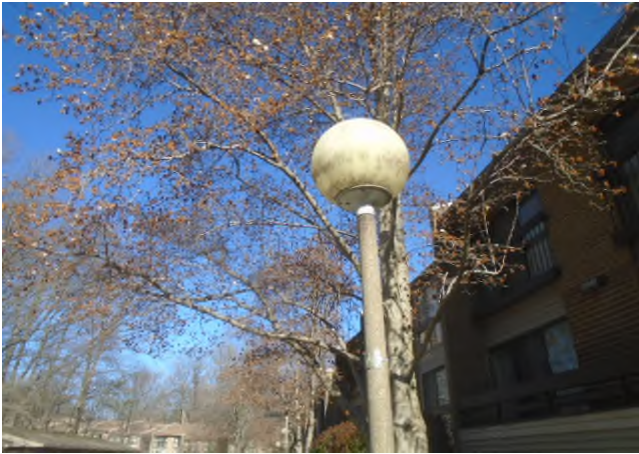
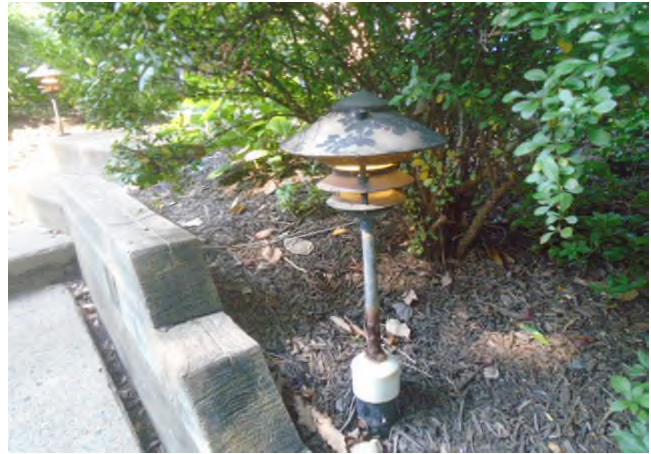
Property appearance is being compromised because parts for street lights are no longer available and a variety of poles and fixtures are being substituted. Reserve provides for all poles and fixtures, except for those behind homes, to be replaced to provide a uniform look. Sidewalk lights between units 11604-11606 will also need repairs/replacement when they fail.

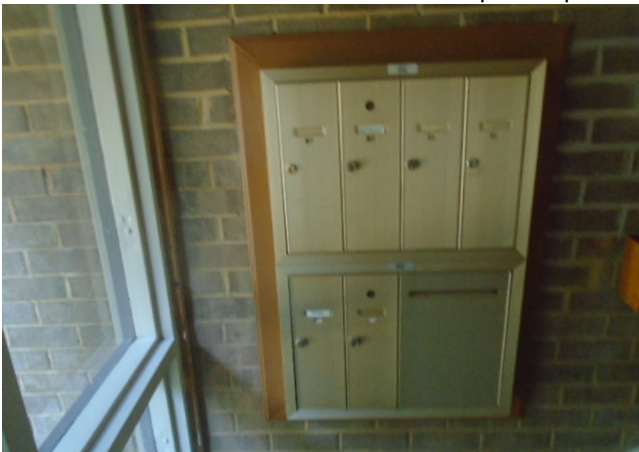
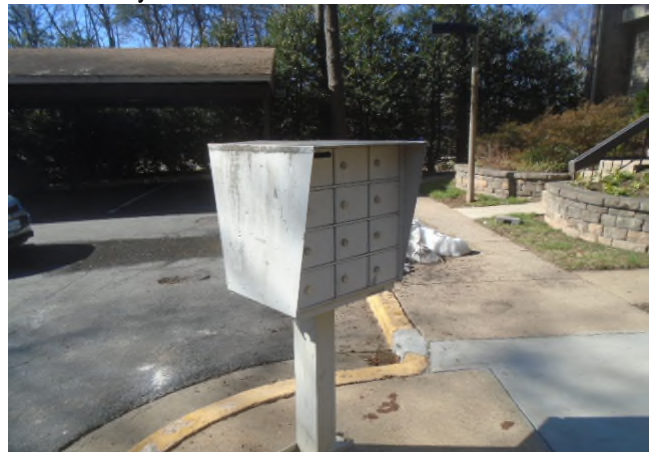
Mailbox replacement will be needed as doors, locks, hinges and other failures occur.

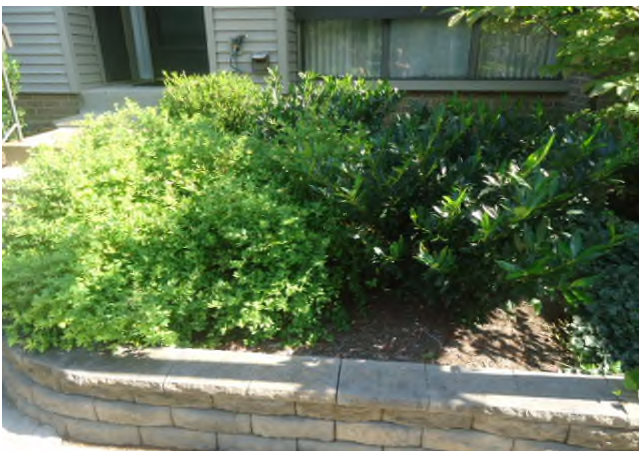
A reasonable amount to replace dead or diseased trees and shrubbery. Does not include normal landscaping upkeep which is funded from the operating account nor large scale improvements.

A reasonable amount to replace dead or diseased trees and shrubbery. Does not include normal landscaping upkeep which is funded from the operating account nor large scale improvements.

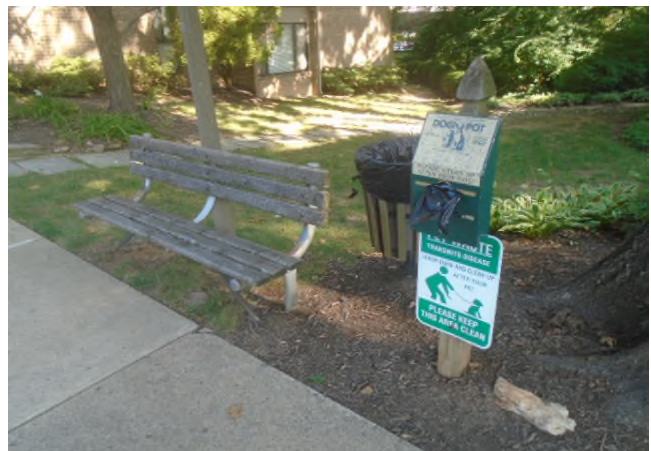
Also included in the reserves are signs, sign posts, picnic tables, park benches, grills and other miscellaneous components. Well-maintained components enhance property appearance.
